PROPERTY CONDITION ASSESSMENT
OF
WORLD TRADE CENTER PORTFOLIO

FOUR WORLD TRADE CENTER

Property #4
Merritt & Harris, Inc. Project Number 20-251E

Re: **Due Diligence Physical Condition Survey**
World Trade Center
New York, New York

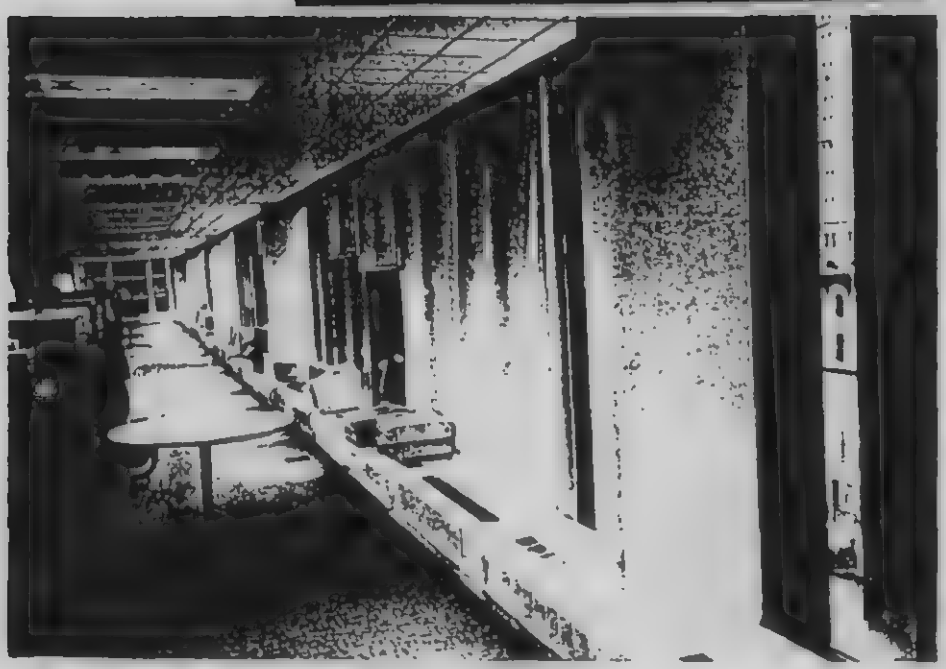
Photograph 22

Office space along window wall

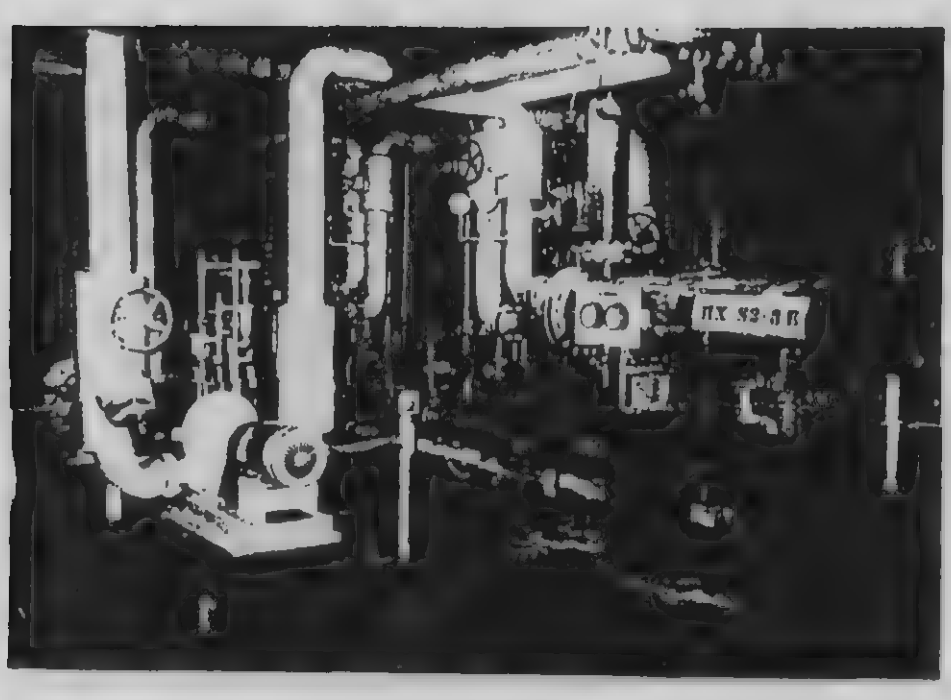
Photograph M6

Heat exchanger and circulating pump for heating hot water

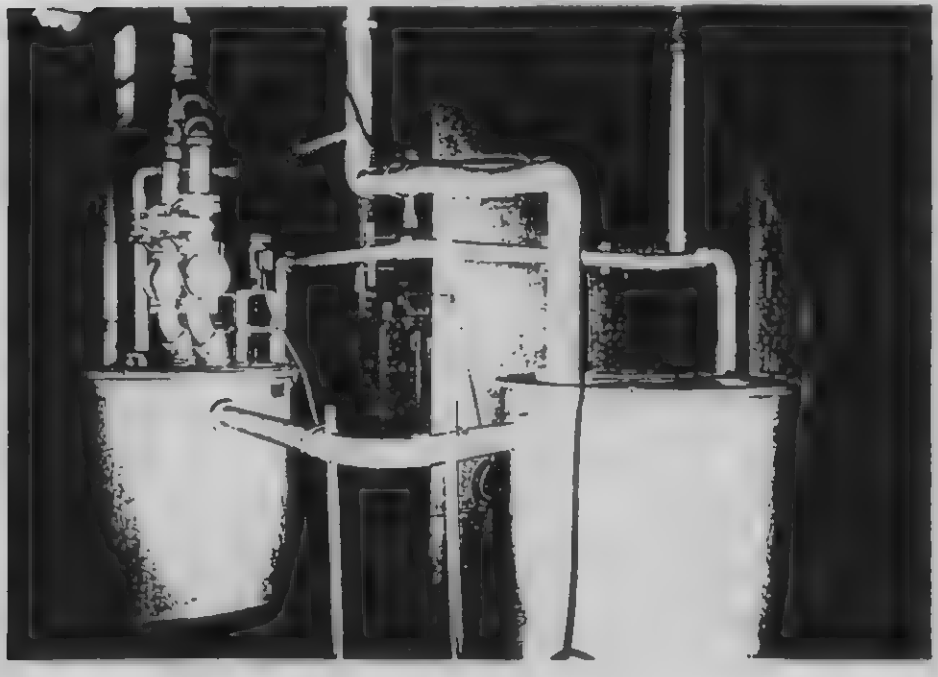
Photograph M7

Ejectors and tanks located in the B1 mechanical room

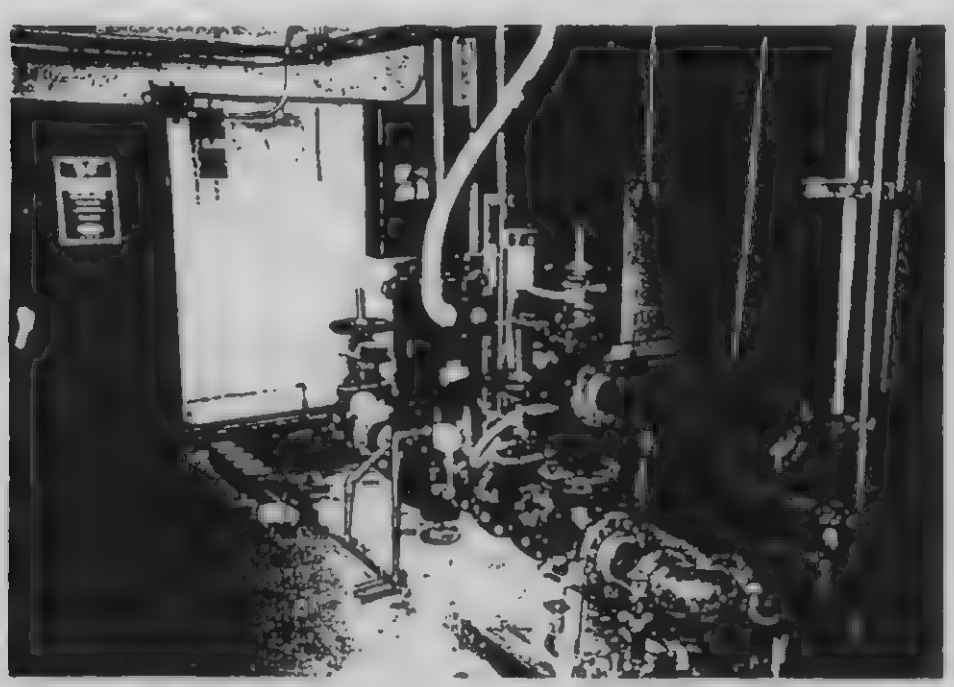
Photograph M11

Booster fire pump located in the 9th floor mechanical room

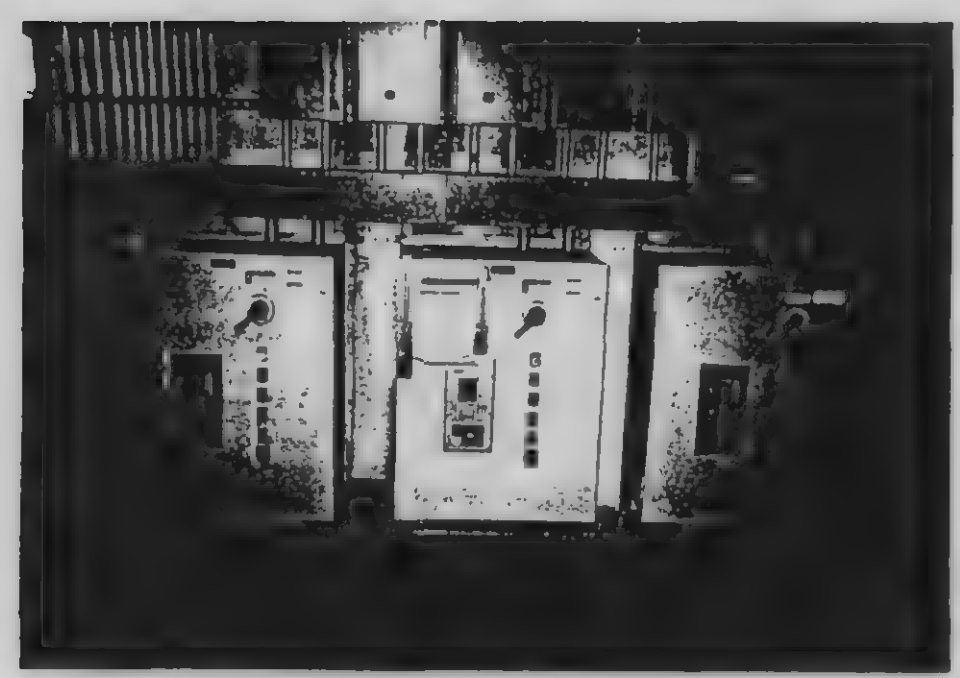
Photograph M12

Variable frequency drive controllers for the air handler supply fans in the 3rd floor mechanical room
